M-10 (LODGE FREEWAY) EMERGENCY RETAINING WALL PROJECTS

Peter Jansson - MDOT Bridge Field Services
Tia Klein - Fishbeck, Thompson, Carr & Huber
Peter MacAskill – Hubbell, Roth & Clark, Inc.

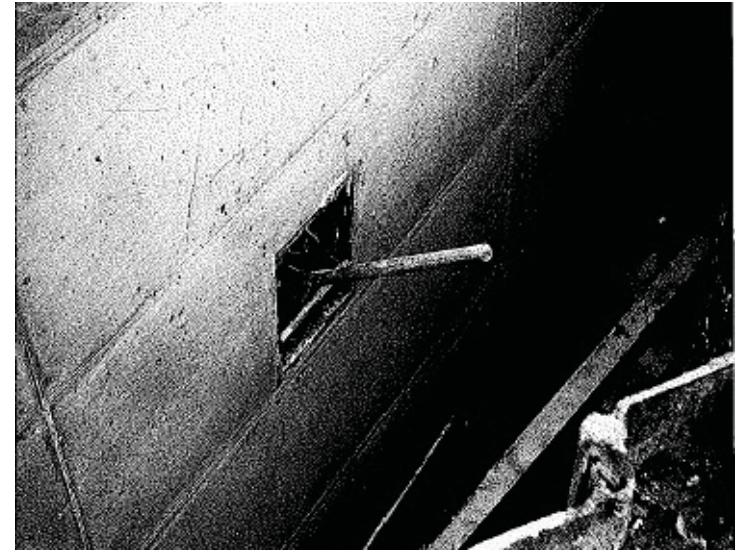
PT bar prior to tensioning and cut off

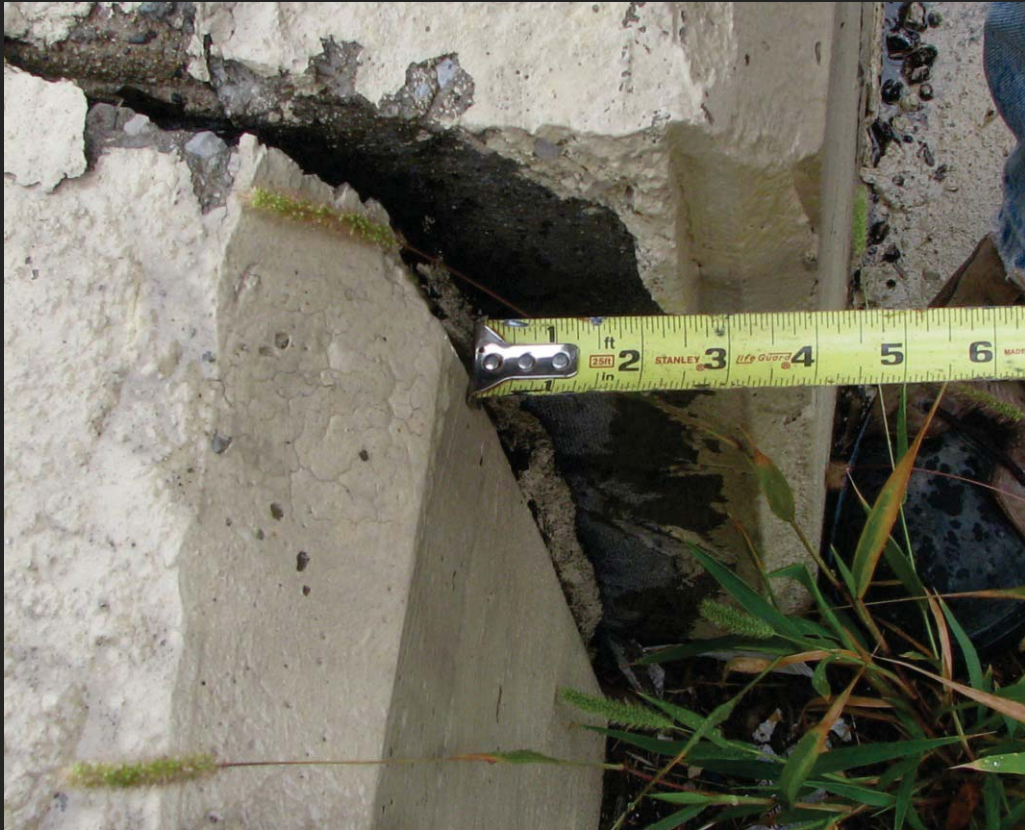
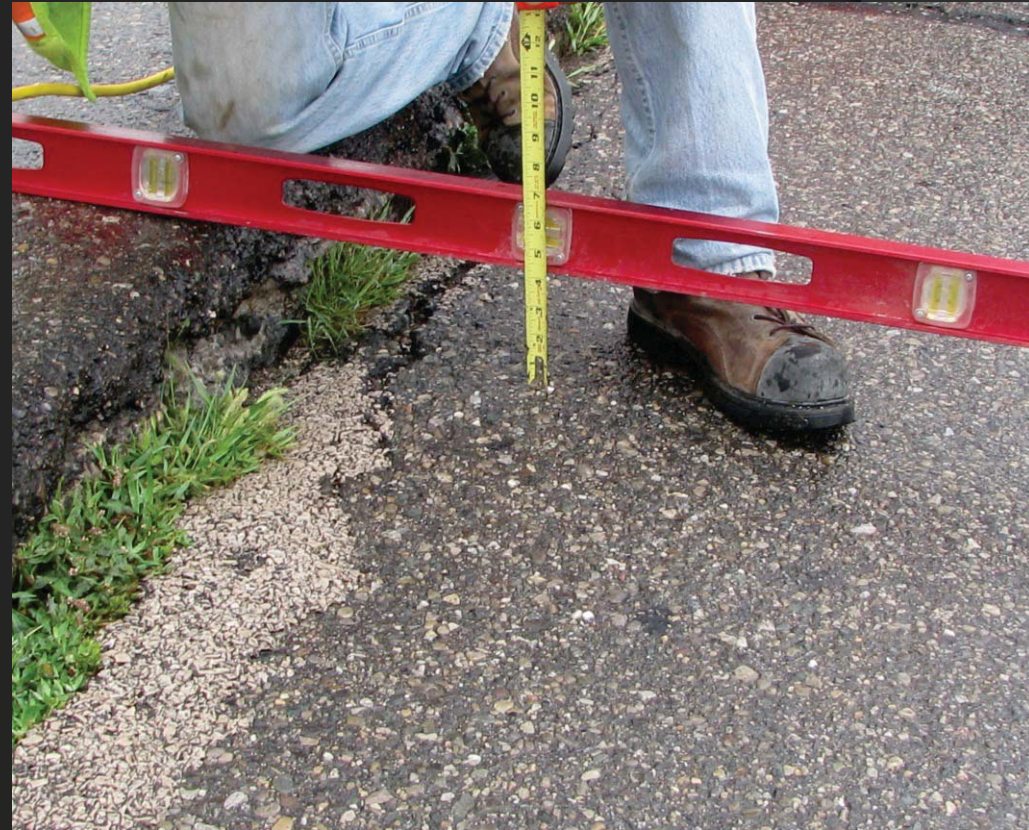
Wall movement = pavement movement

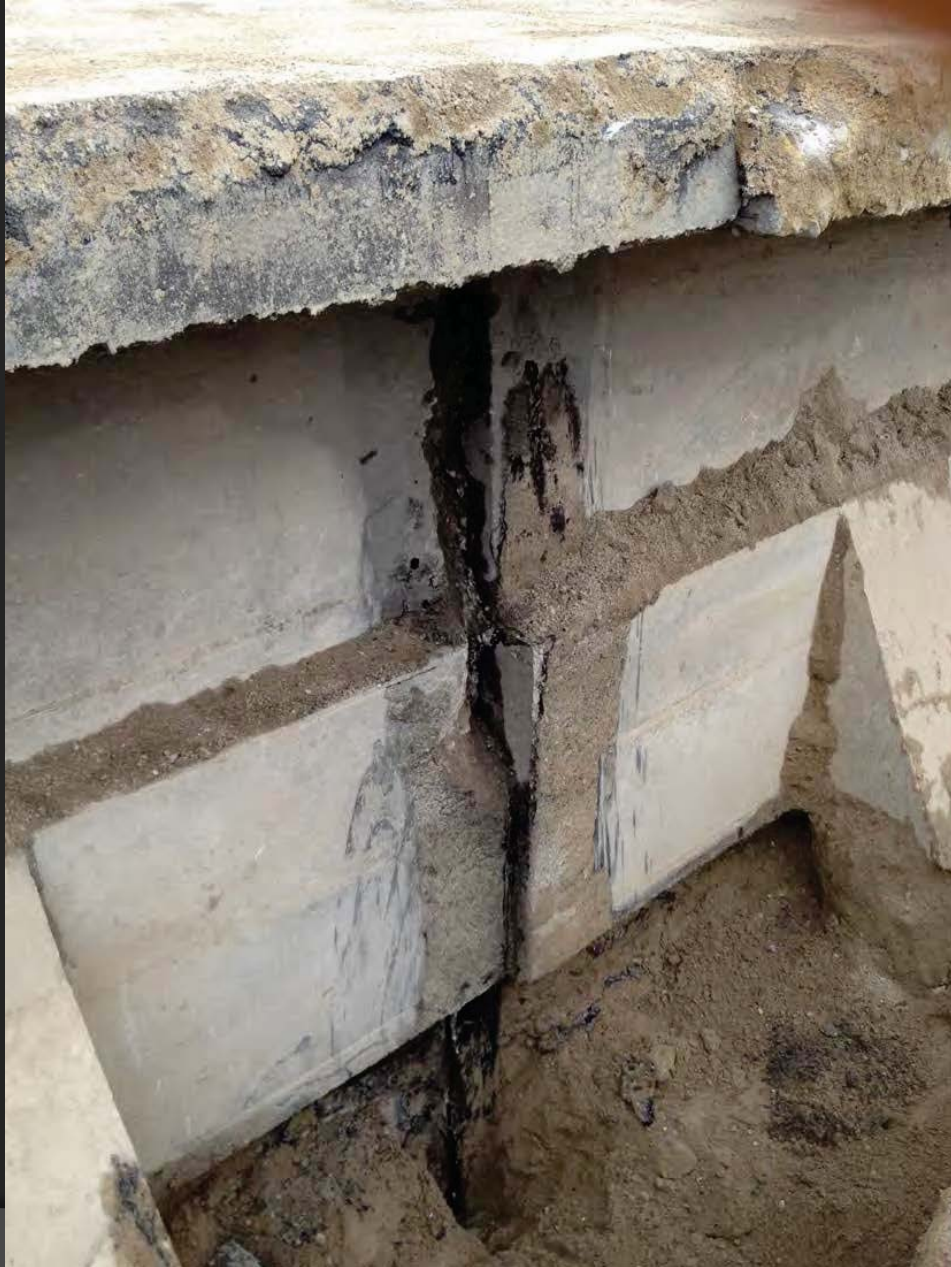
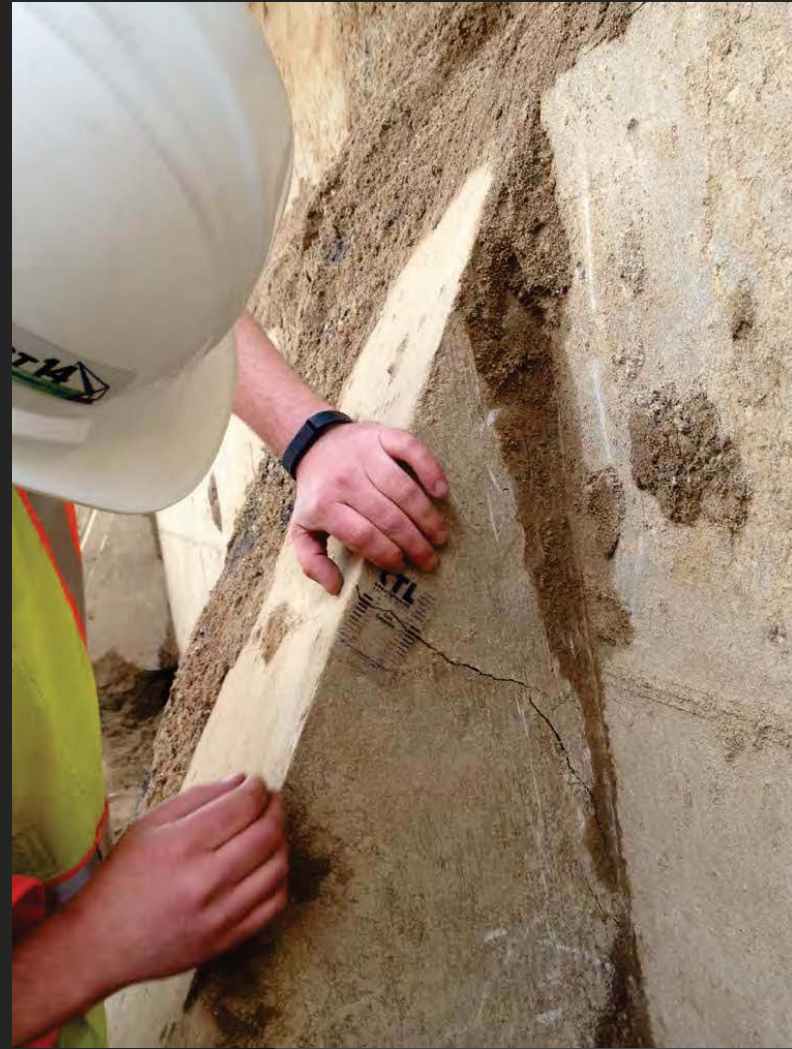
Exposed wall joint and cracked anchor block

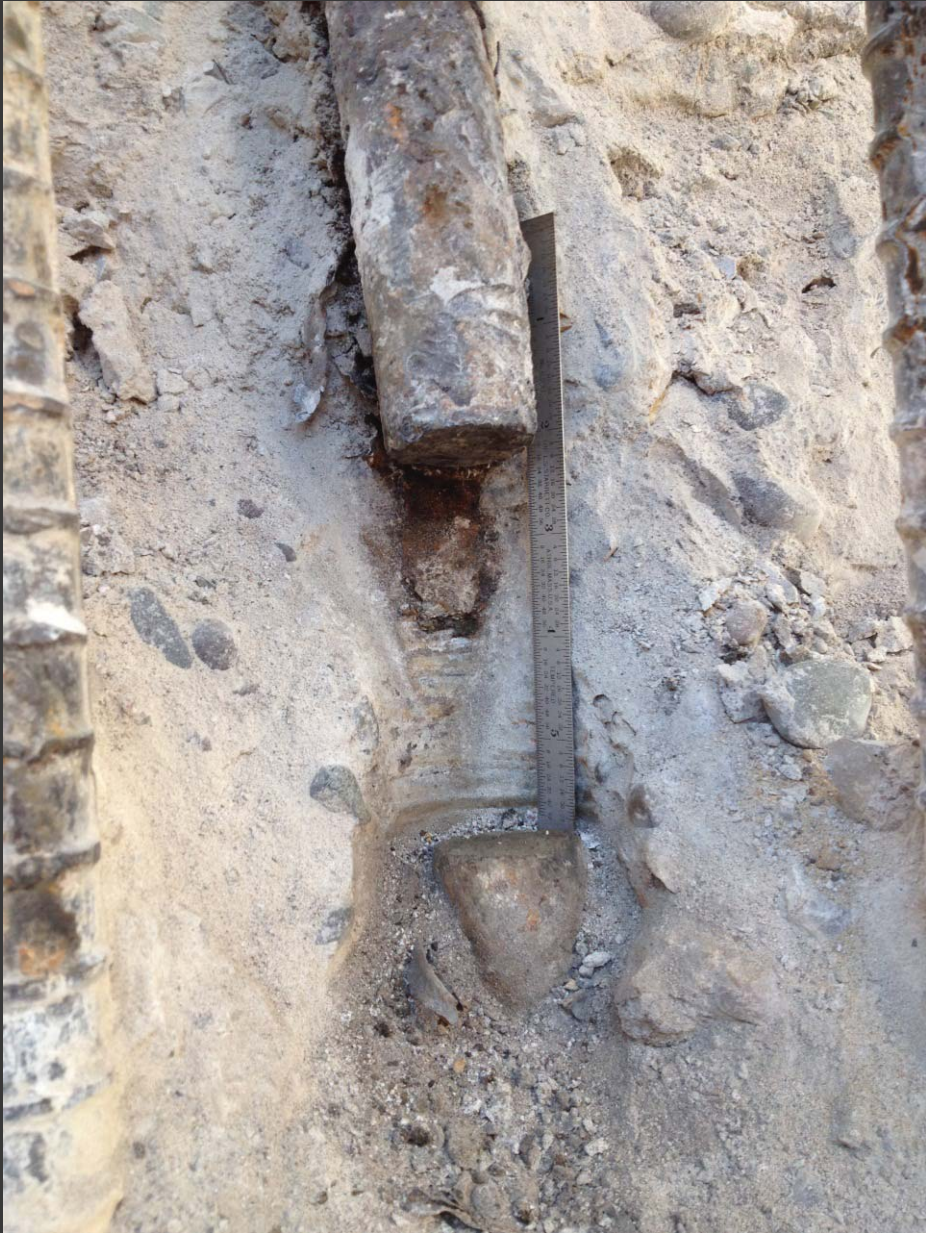
Fractured PT Bar

- ① One (or more) PT bars fractured
 - examination of the fracture surface suggests that fracture occurred years ago.
- ① Some PT duct grout was missing or deteriorated
- ① Some concrete anchor blocks exhibited active cracking
- ① Most concrete caissons exhibited circumferential cracking close to the wall

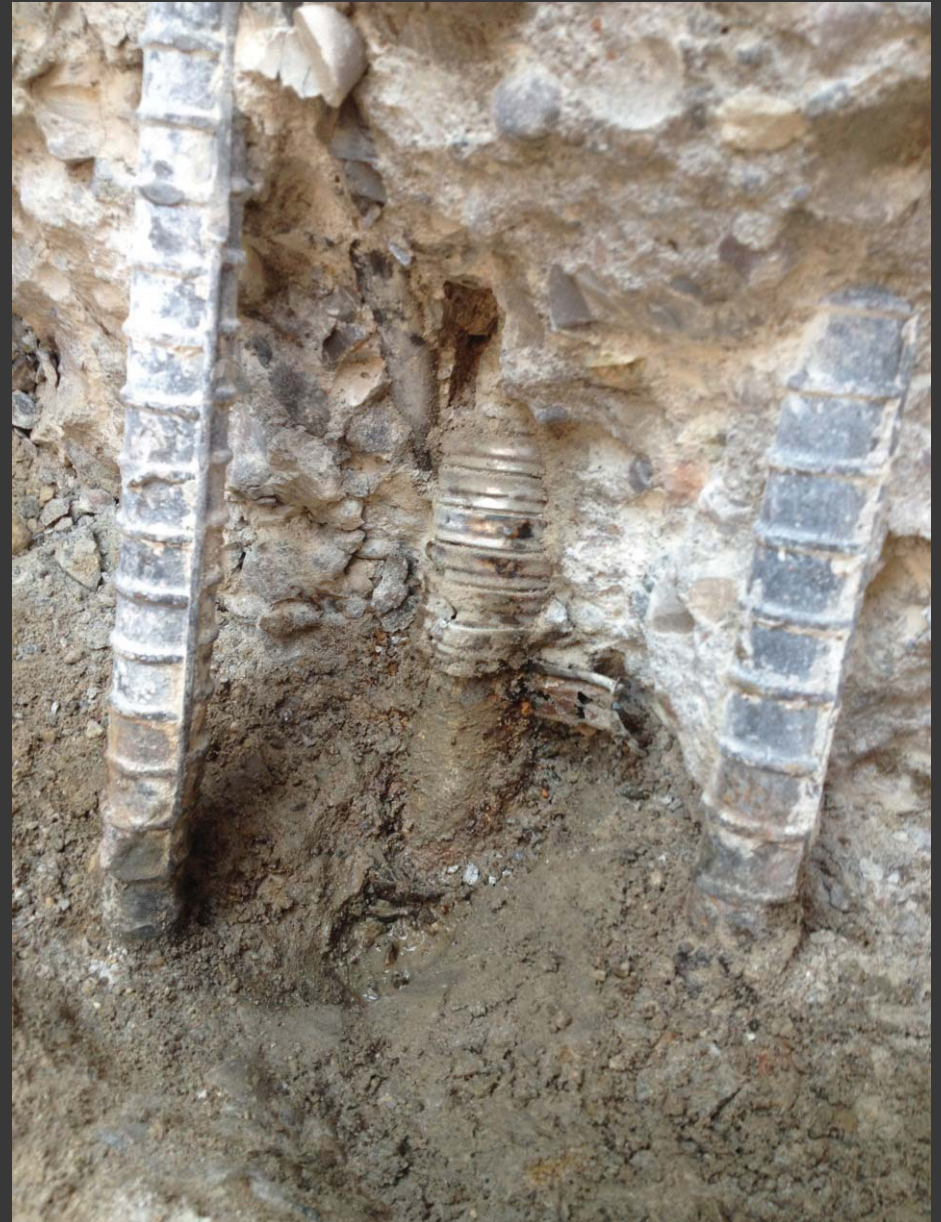
Deteriorated Concrete

- Some of the caisson concrete appeared deteriorated or had been poorly mixed/consolidated
 - water was present on the interior of several caissons.
- Torch cutting of the PT bar wall anchorages to the wall suggested some bars had already relaxed/unloaded
- Significant corrosion and loss of section was found in the footing to wall rebar

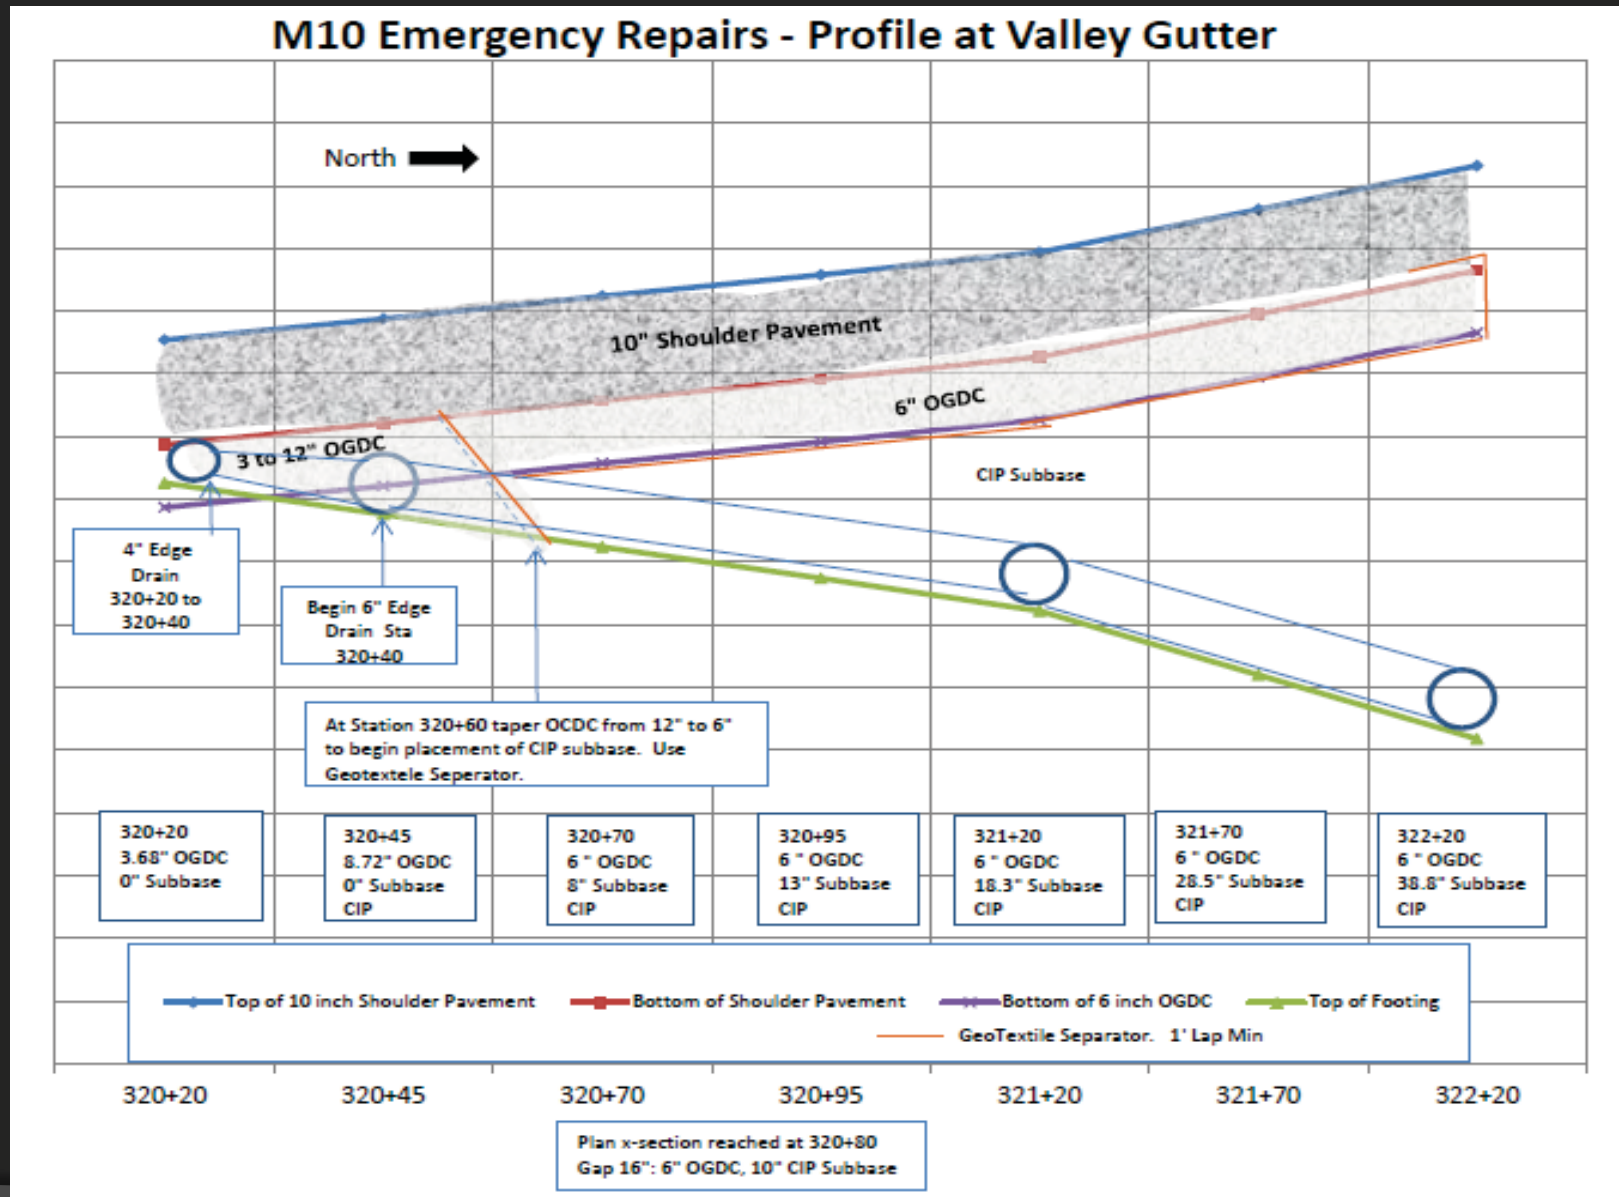
Construction Issues – Shoulder / Footing Conflict

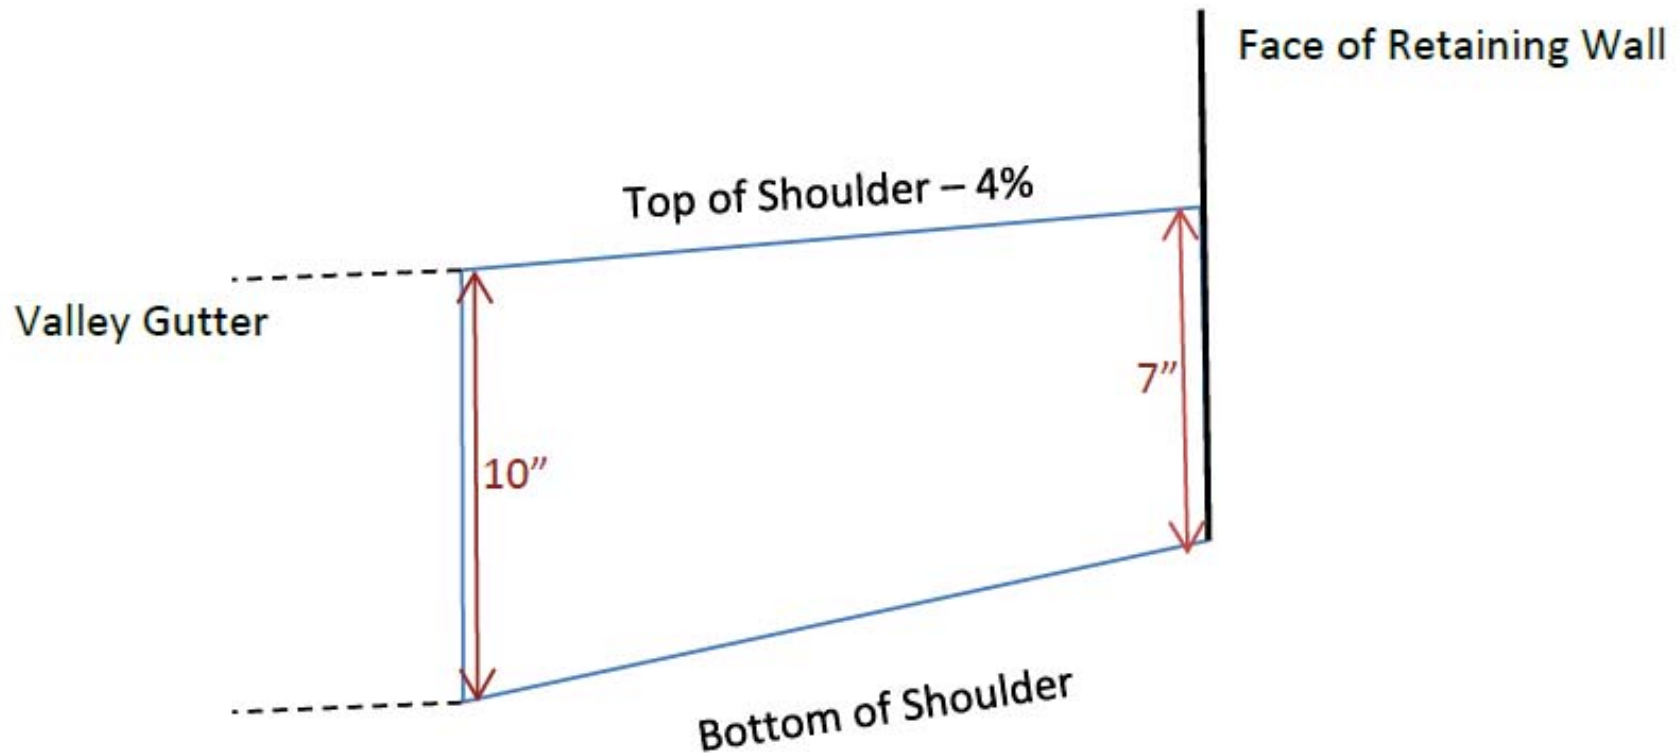
Construction Issues – Shoulder / Footing Conflict

120697A Shoulder Width 320+20 to 320+80

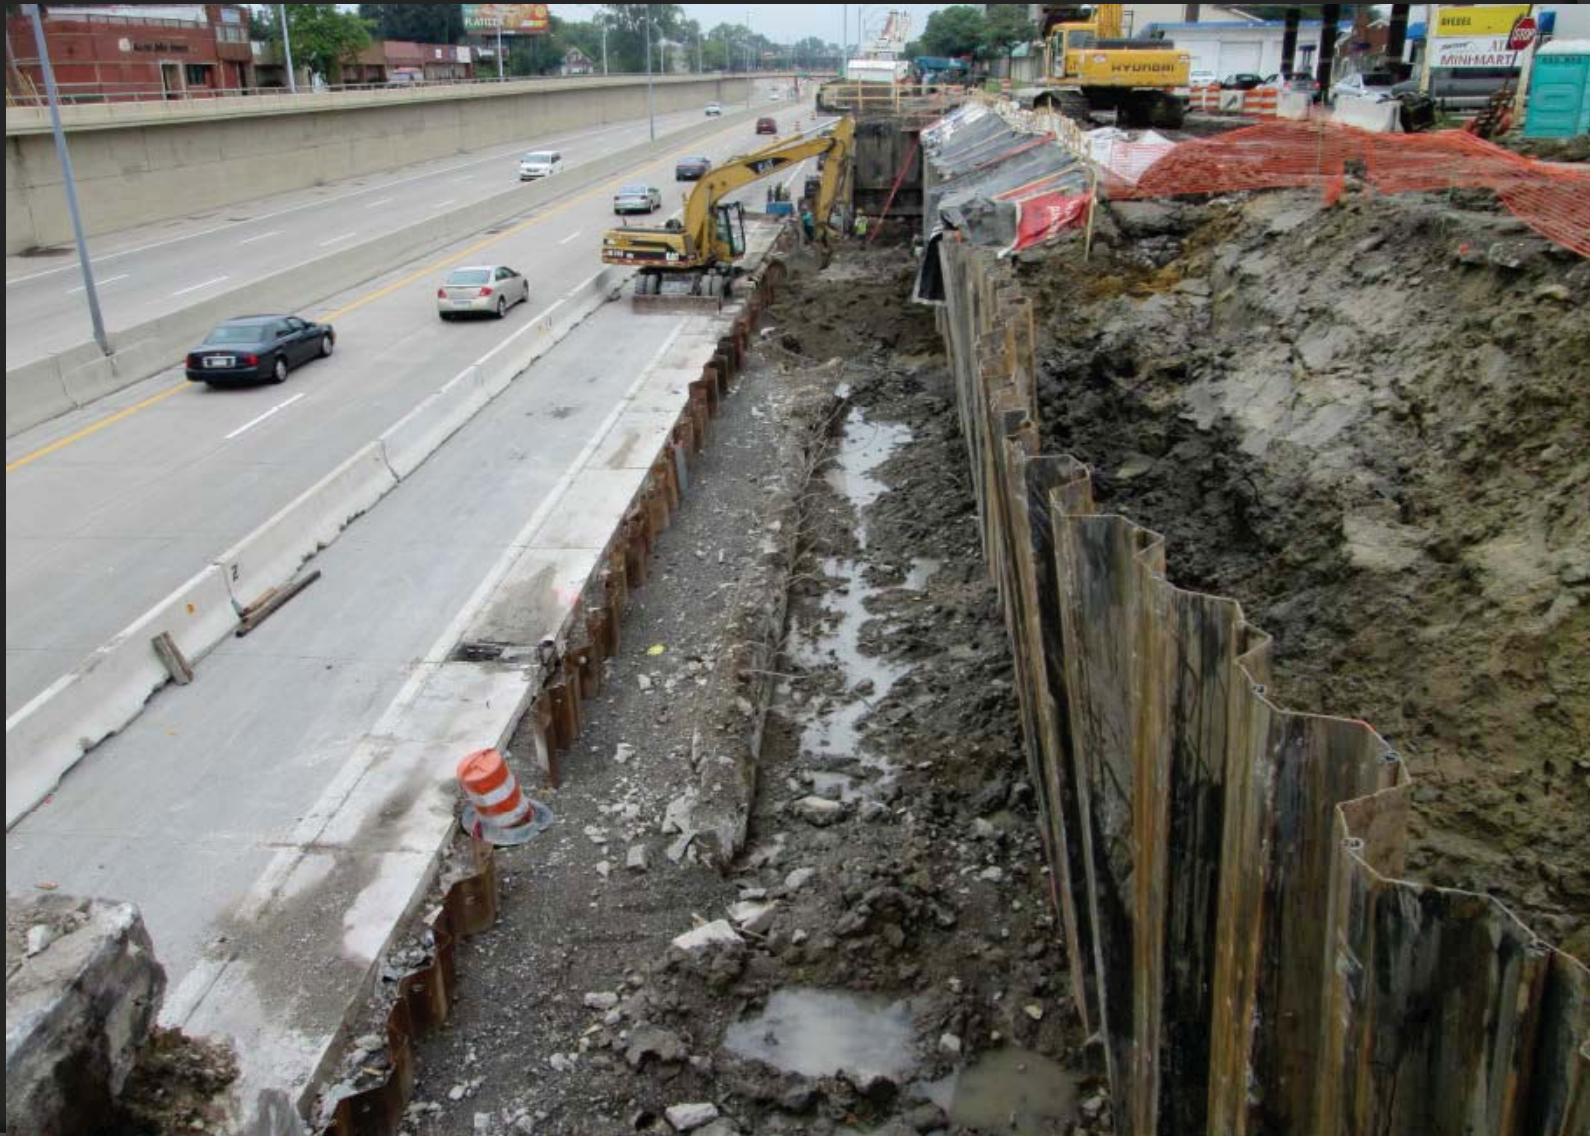
Construction Issues – Water Main Break

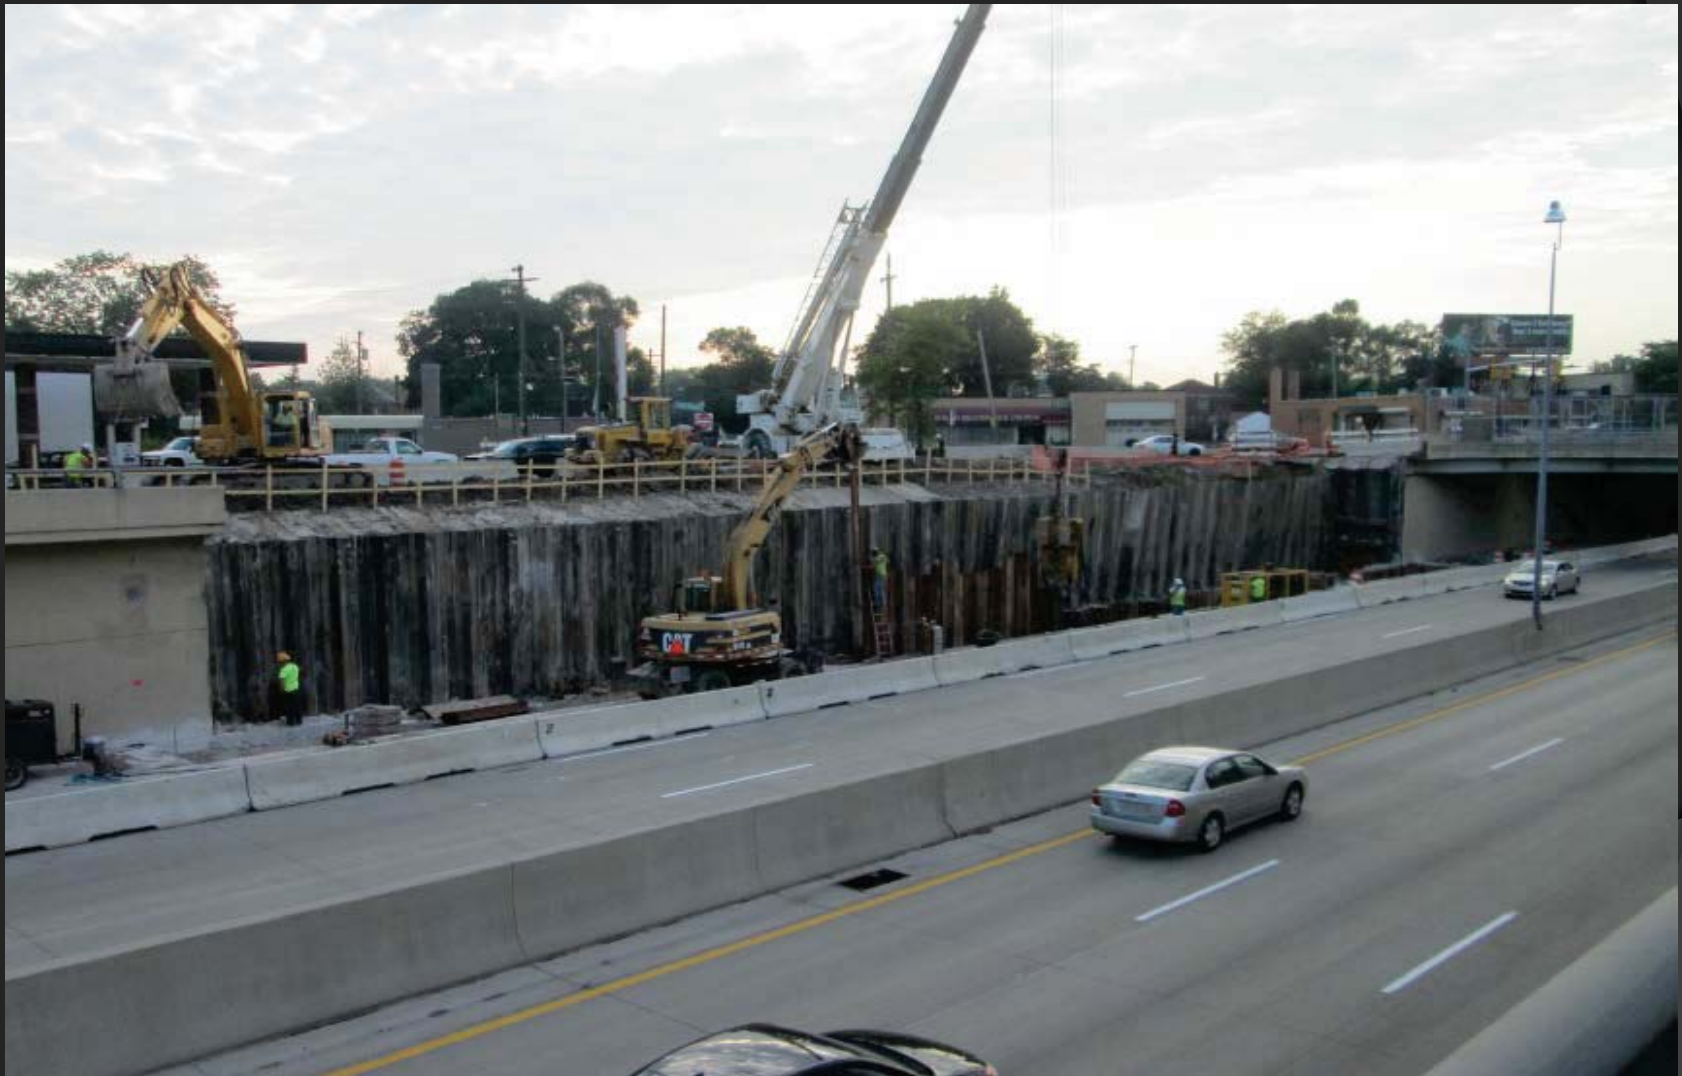
Construction Issues – Water Main Break

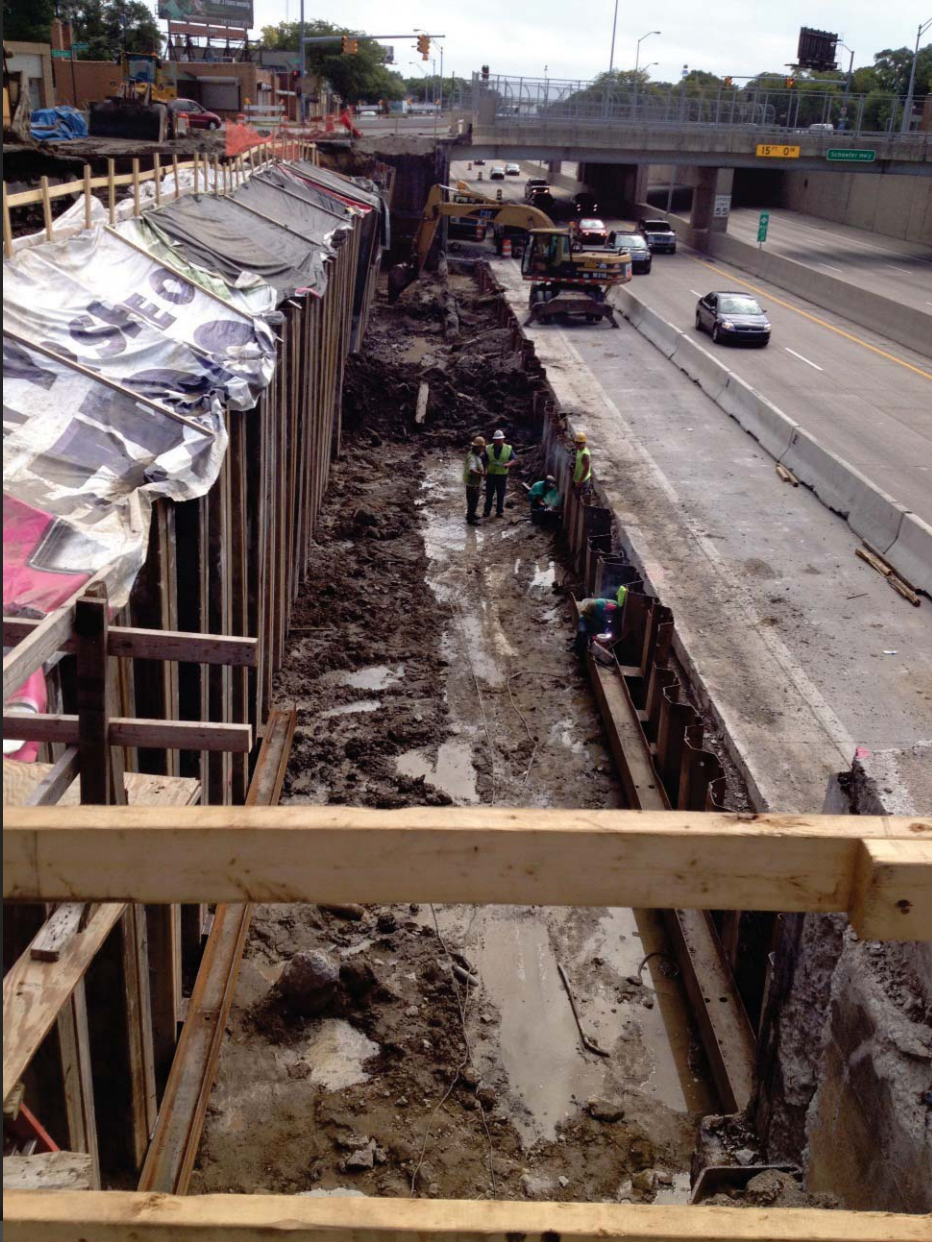
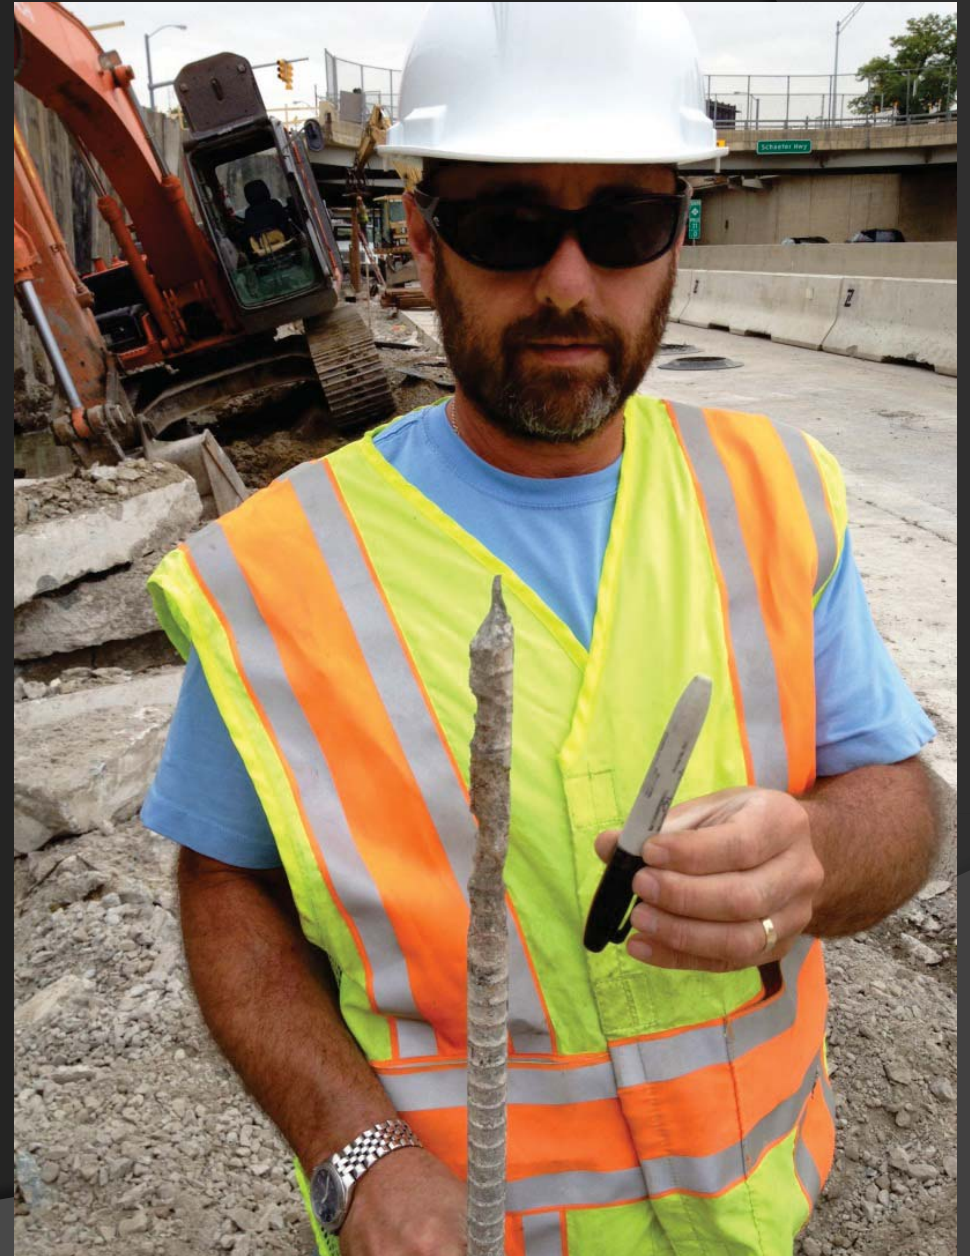
Rebar from wall into footing
