M-10 (LODGE FREEWAY) EMERGENCY RETAINING WALL PROJECTS

Peter Jansson - MDOT Bridge Field Services
Tia Klein - Fishbeck, Thompson, Carr & Huber
Peter MacAskill – Hubbell, Roth & Clark, Inc.

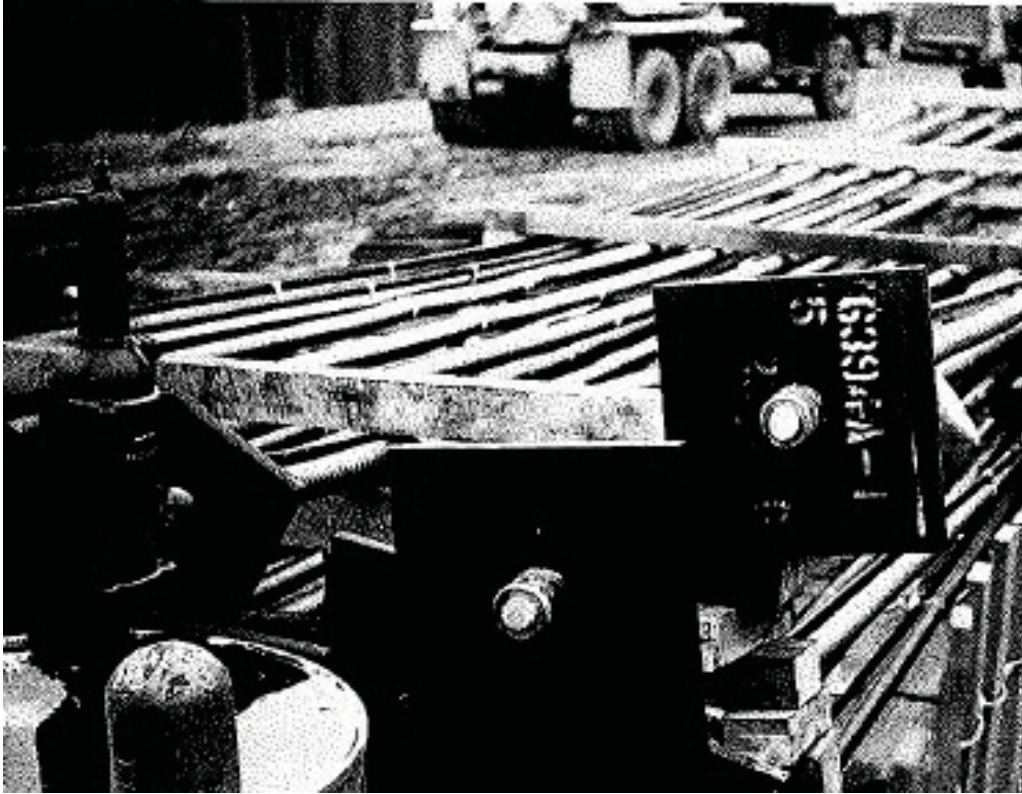
Anchorage plate at end of caisson

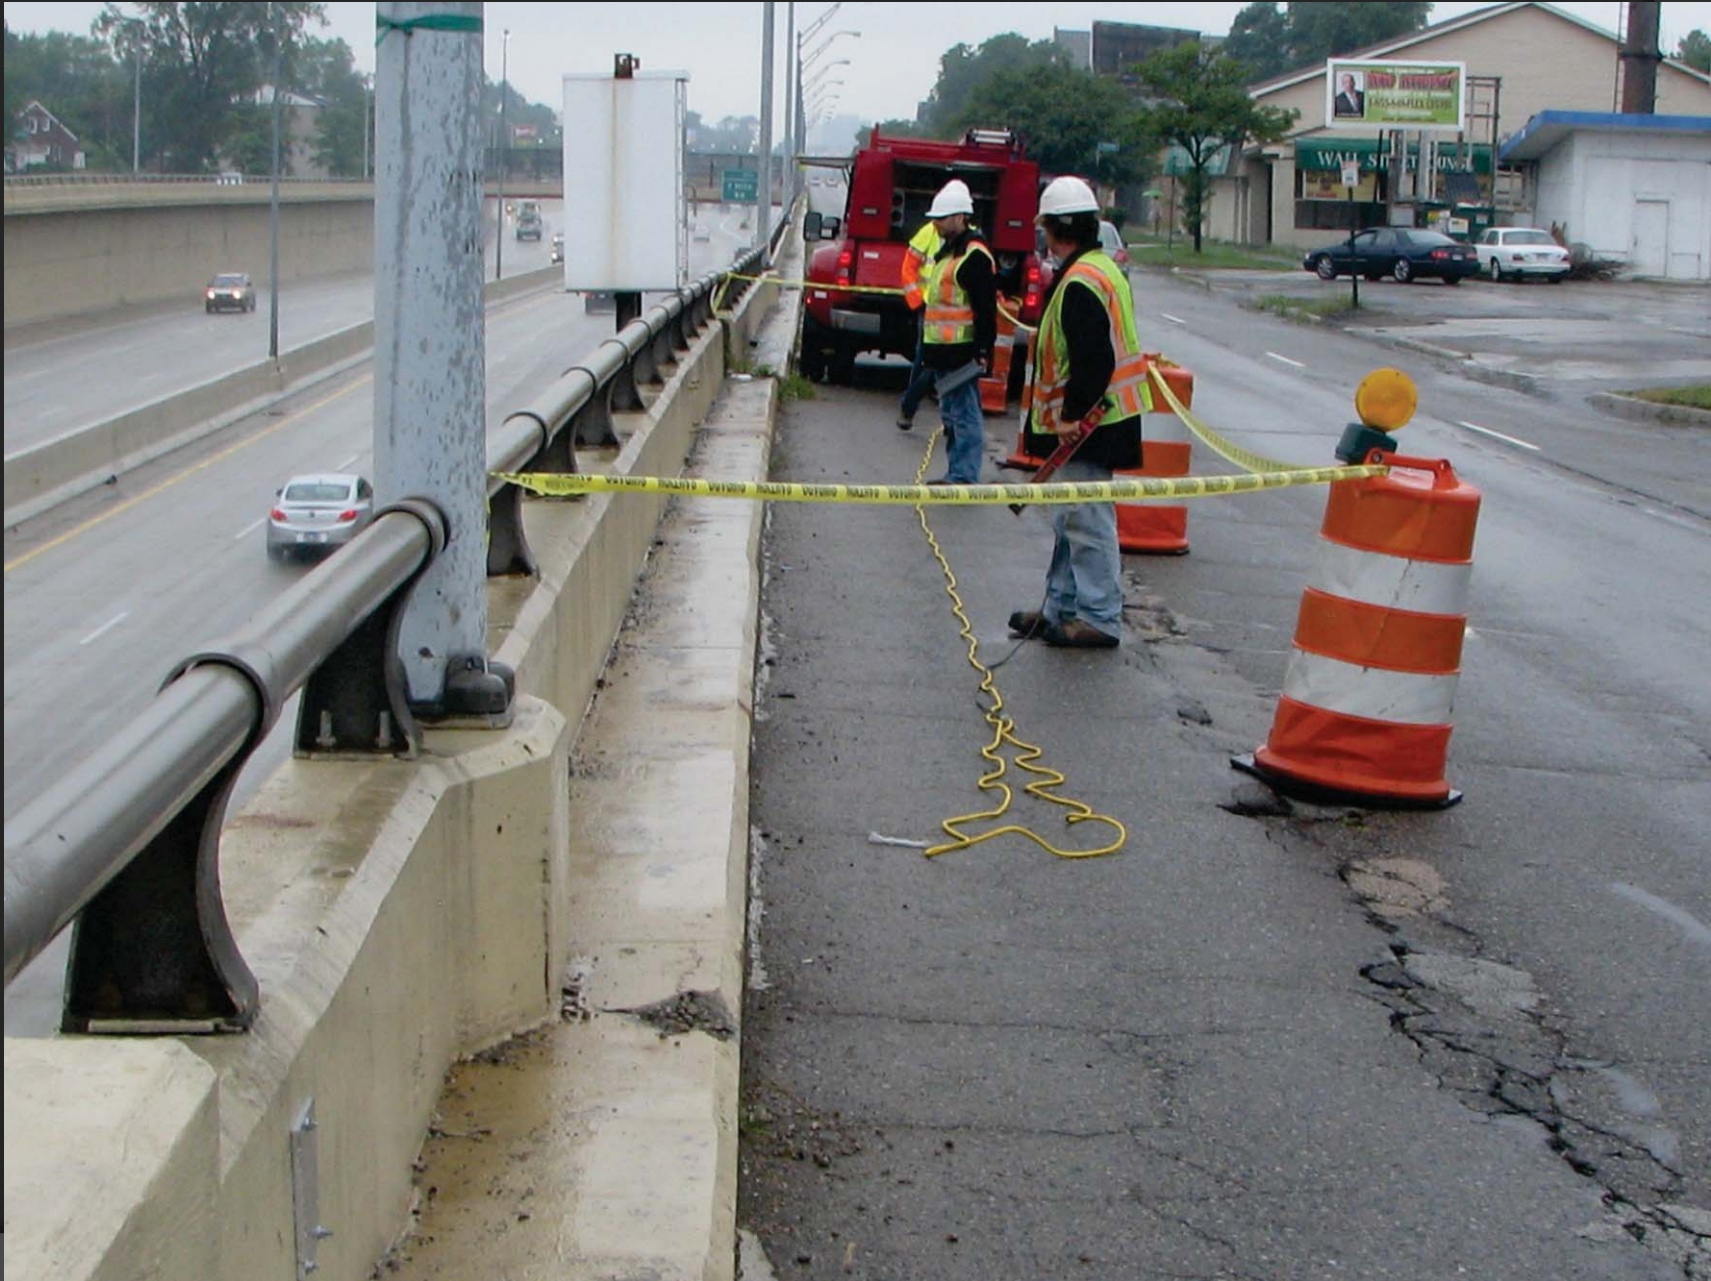
NB Service Dr. at Schaefer

Wall movement = pavement movement

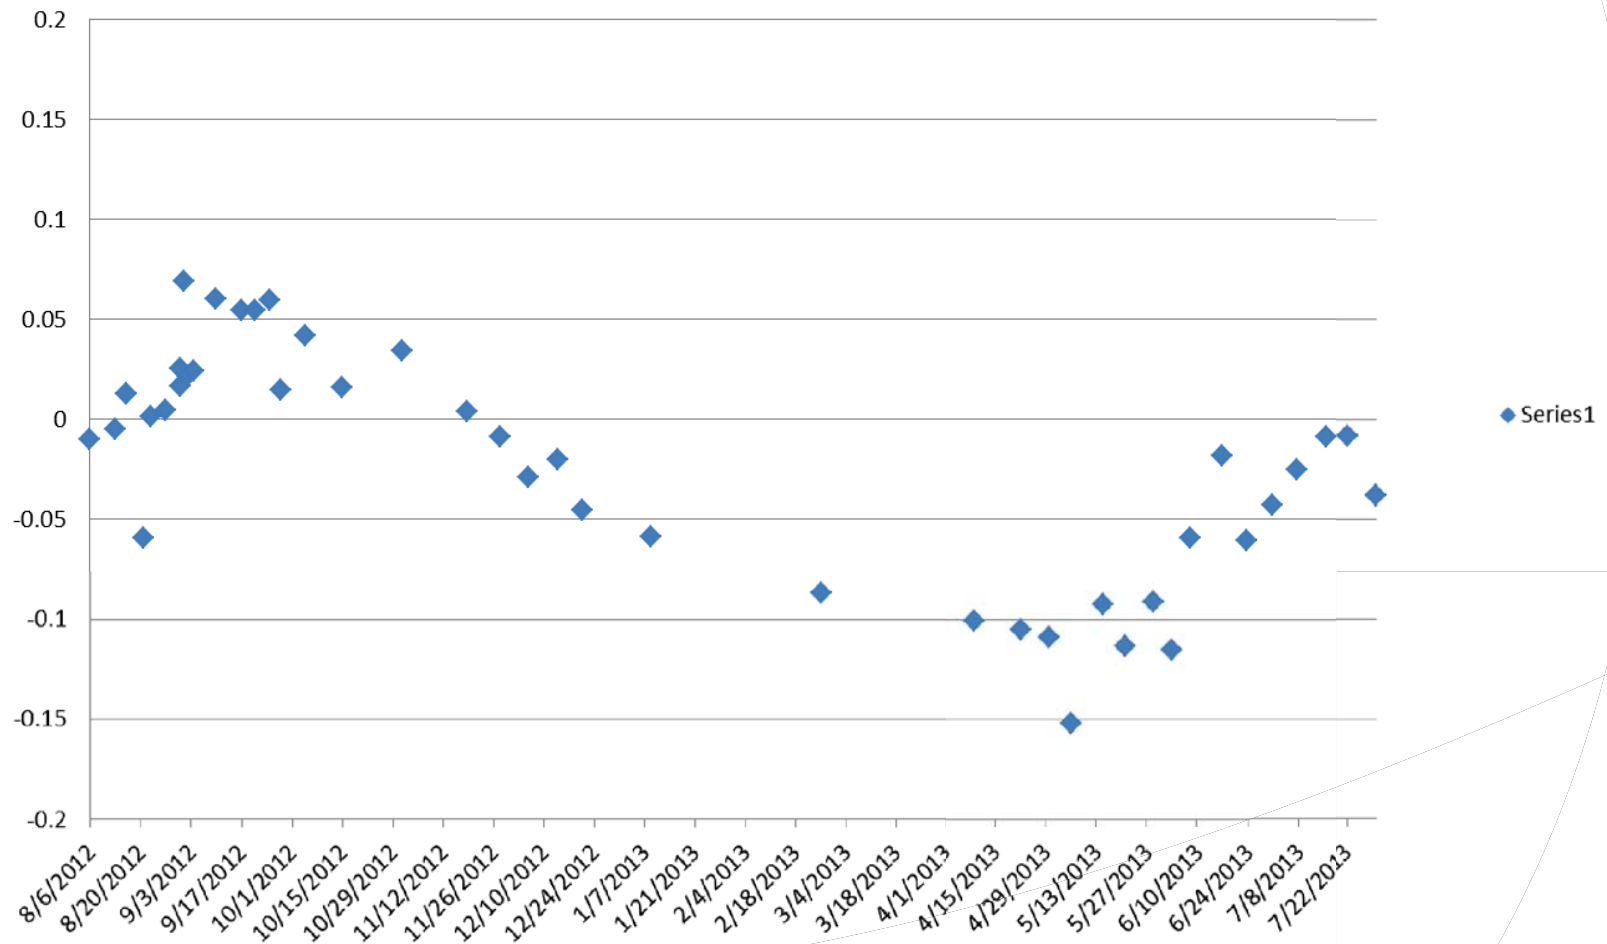
Tilt Sensor Data – M10 at base of wall

Change in Degrees from Initial Reading

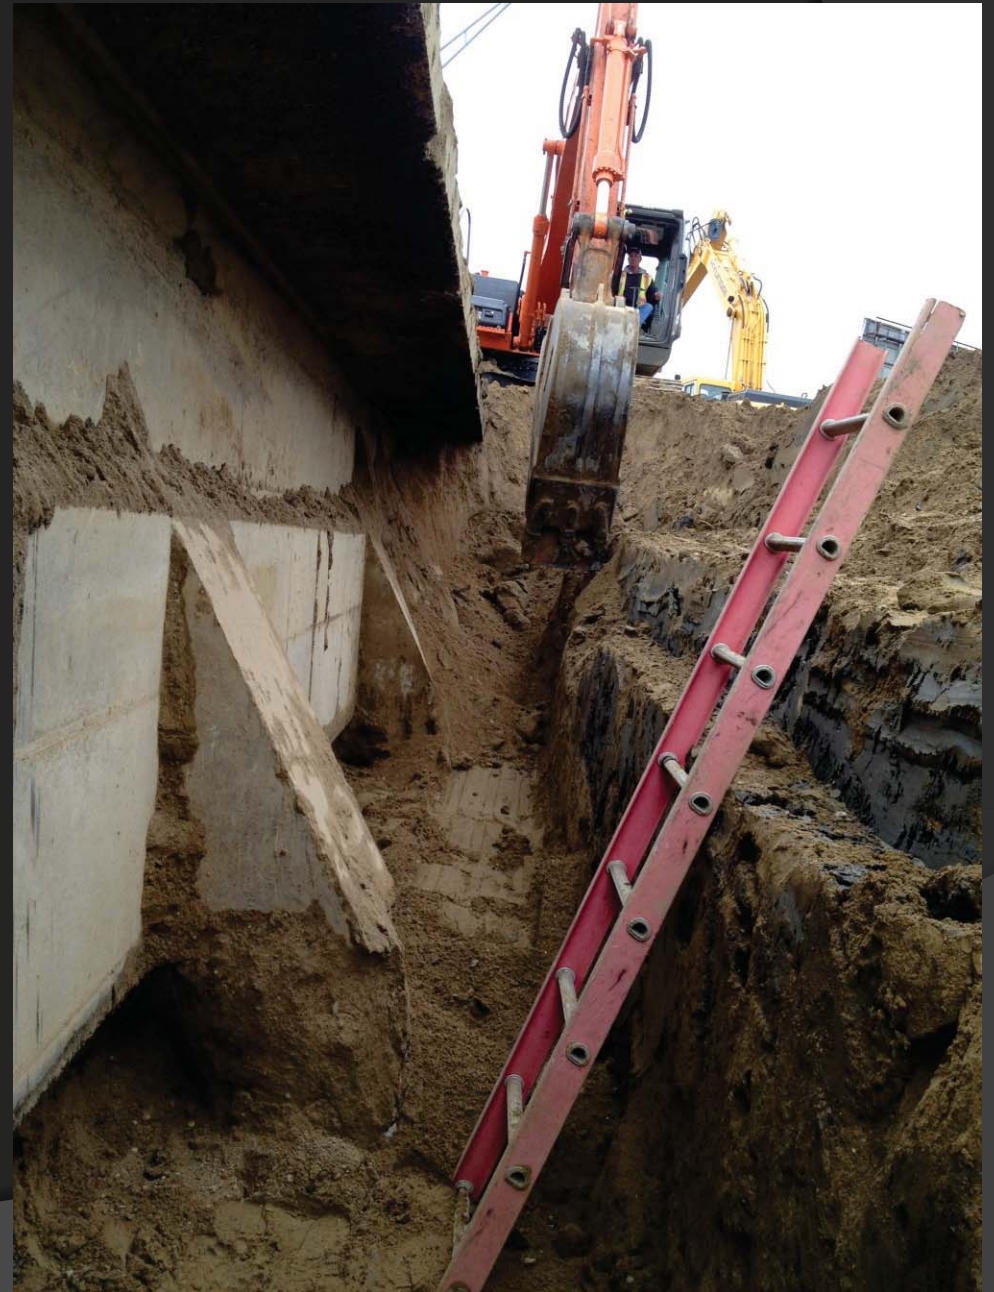
Excavation Begins

- ⦿ Saturday June 8, 2013
- ⦿ Closed Service Drive
- ⦿ M10 Lane Closures for safety
- ⦿ Excavated behind 200 ft. of wall 10 ft. + depth
- ⦿ Exposed Footing
- ⦿ Hand Exposed Caissons

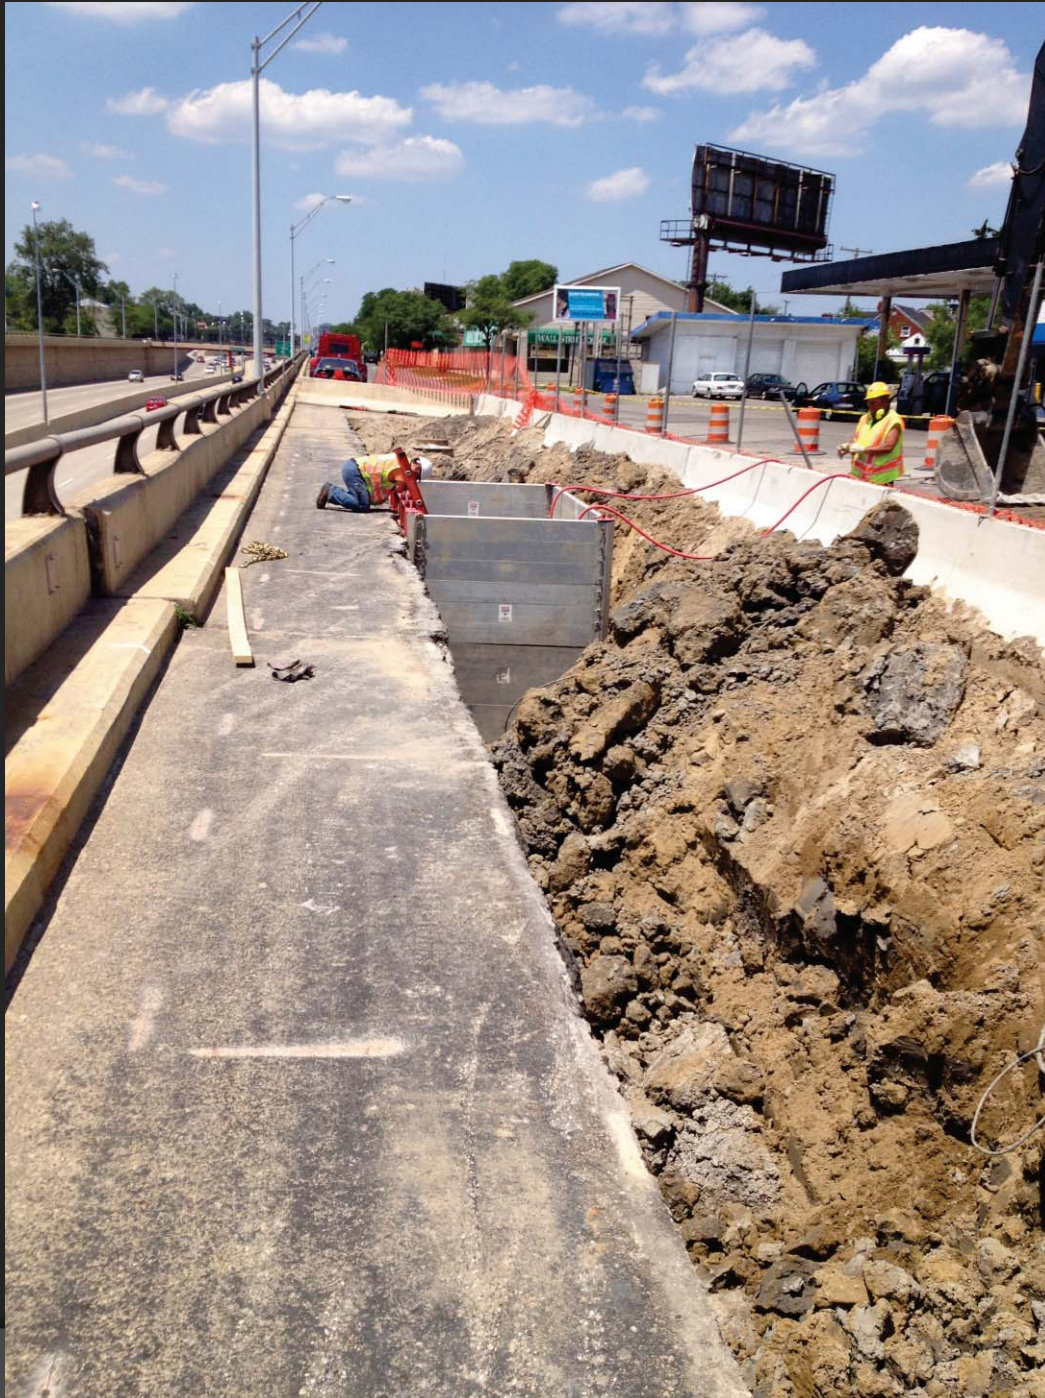
Caisson exposure and chipping

Findings:

- Cracked anchor blocks
- Fractured PT bar
- Deteriorated grout in PT ducts
- Deteriorated caisson concrete
- Caisson voids

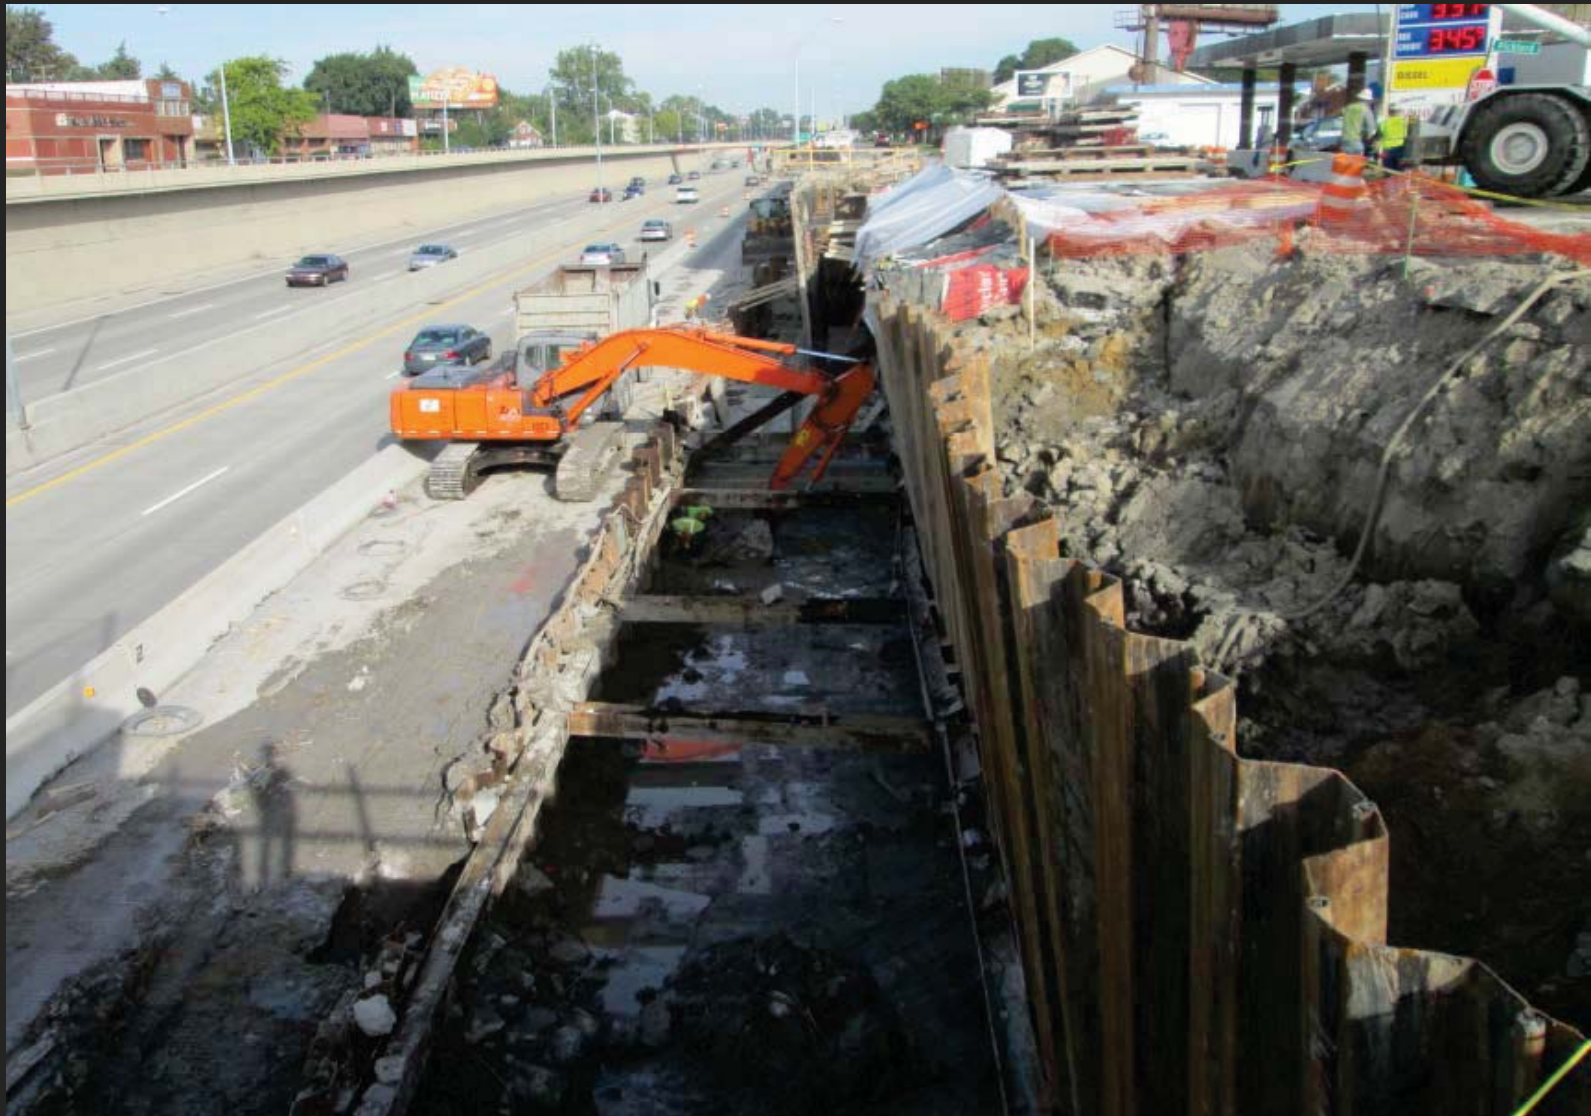
Sheet Piling Cross Bracing

- Contractor stated they could not drive pile to full depth per-plan due to non-vibratory methods
- Submitted revised sheet piling plan with cross bracing
- Revised plan approved
- Water main break occurred prior to cross brace installation

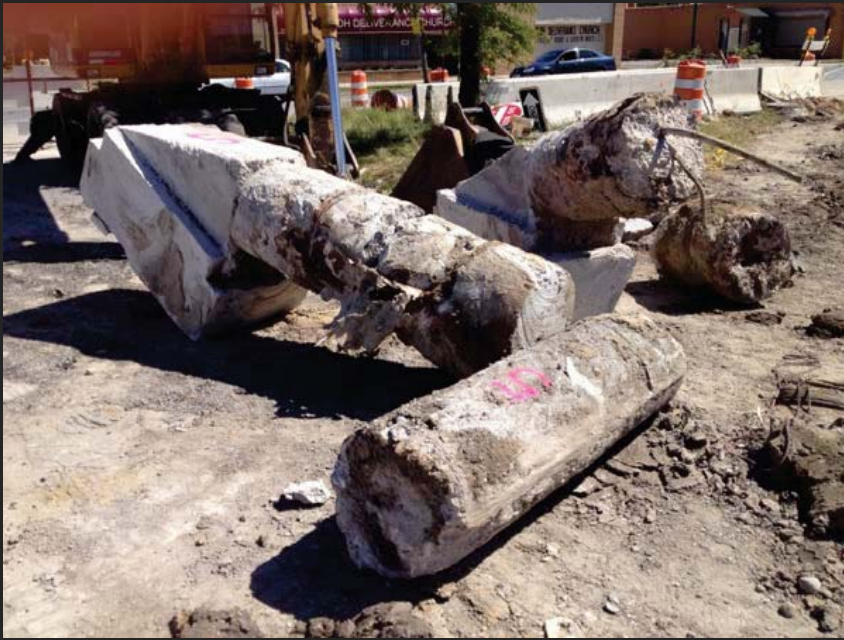
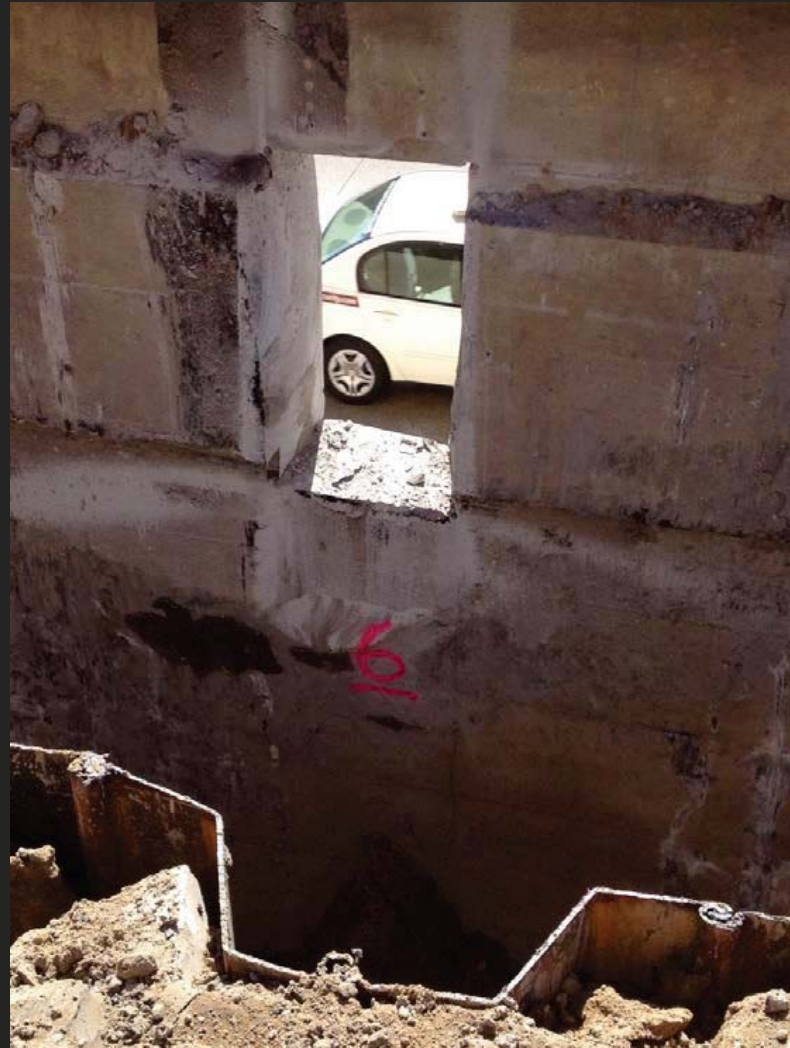
Salvaged Caissons

- ① One (or more) PT bars fractured
 - examination of the fracture surface suggests that fracture occurred years ago.
- ① Some PT duct grout was missing or deteriorated
- ① Some concrete anchor blocks exhibited active cracking
- ① Most concrete caissons exhibited circumferential cracking close to the wall

- Some of the caisson concrete appeared deteriorated or had been poorly mixed/consolidated
 - water was present on the interior of several caissons.
- Torch cutting of the PT bar wall anchorages to the wall suggested some bars had already relaxed/unloaded
- Significant corrosion and loss of section was found in the footing to wall rebar
